CONCEPT PLAN

Southern California Veterans Cemetery Irvine, California

JUNE 2016

Prepared for:
State of California Department of General Services
Project Management and Development Branch

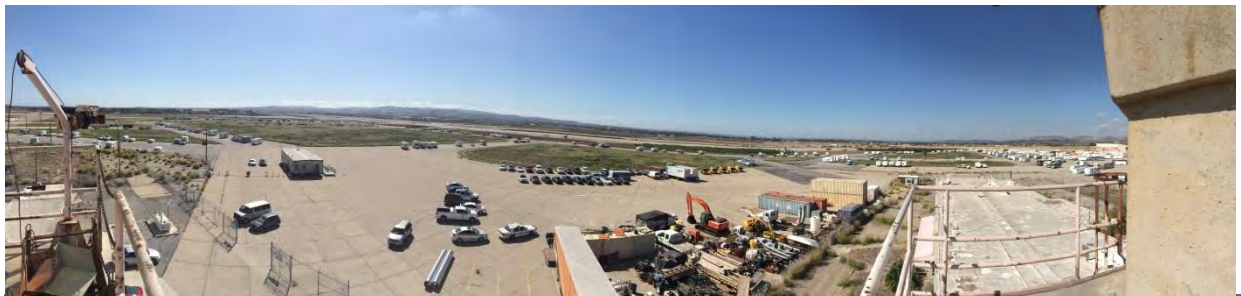
Figure 1: Site Photo

Located in the former MCAS El Toro in the City of Irvine, the SCVC is a 125 acre site of flat, previously developed topography.

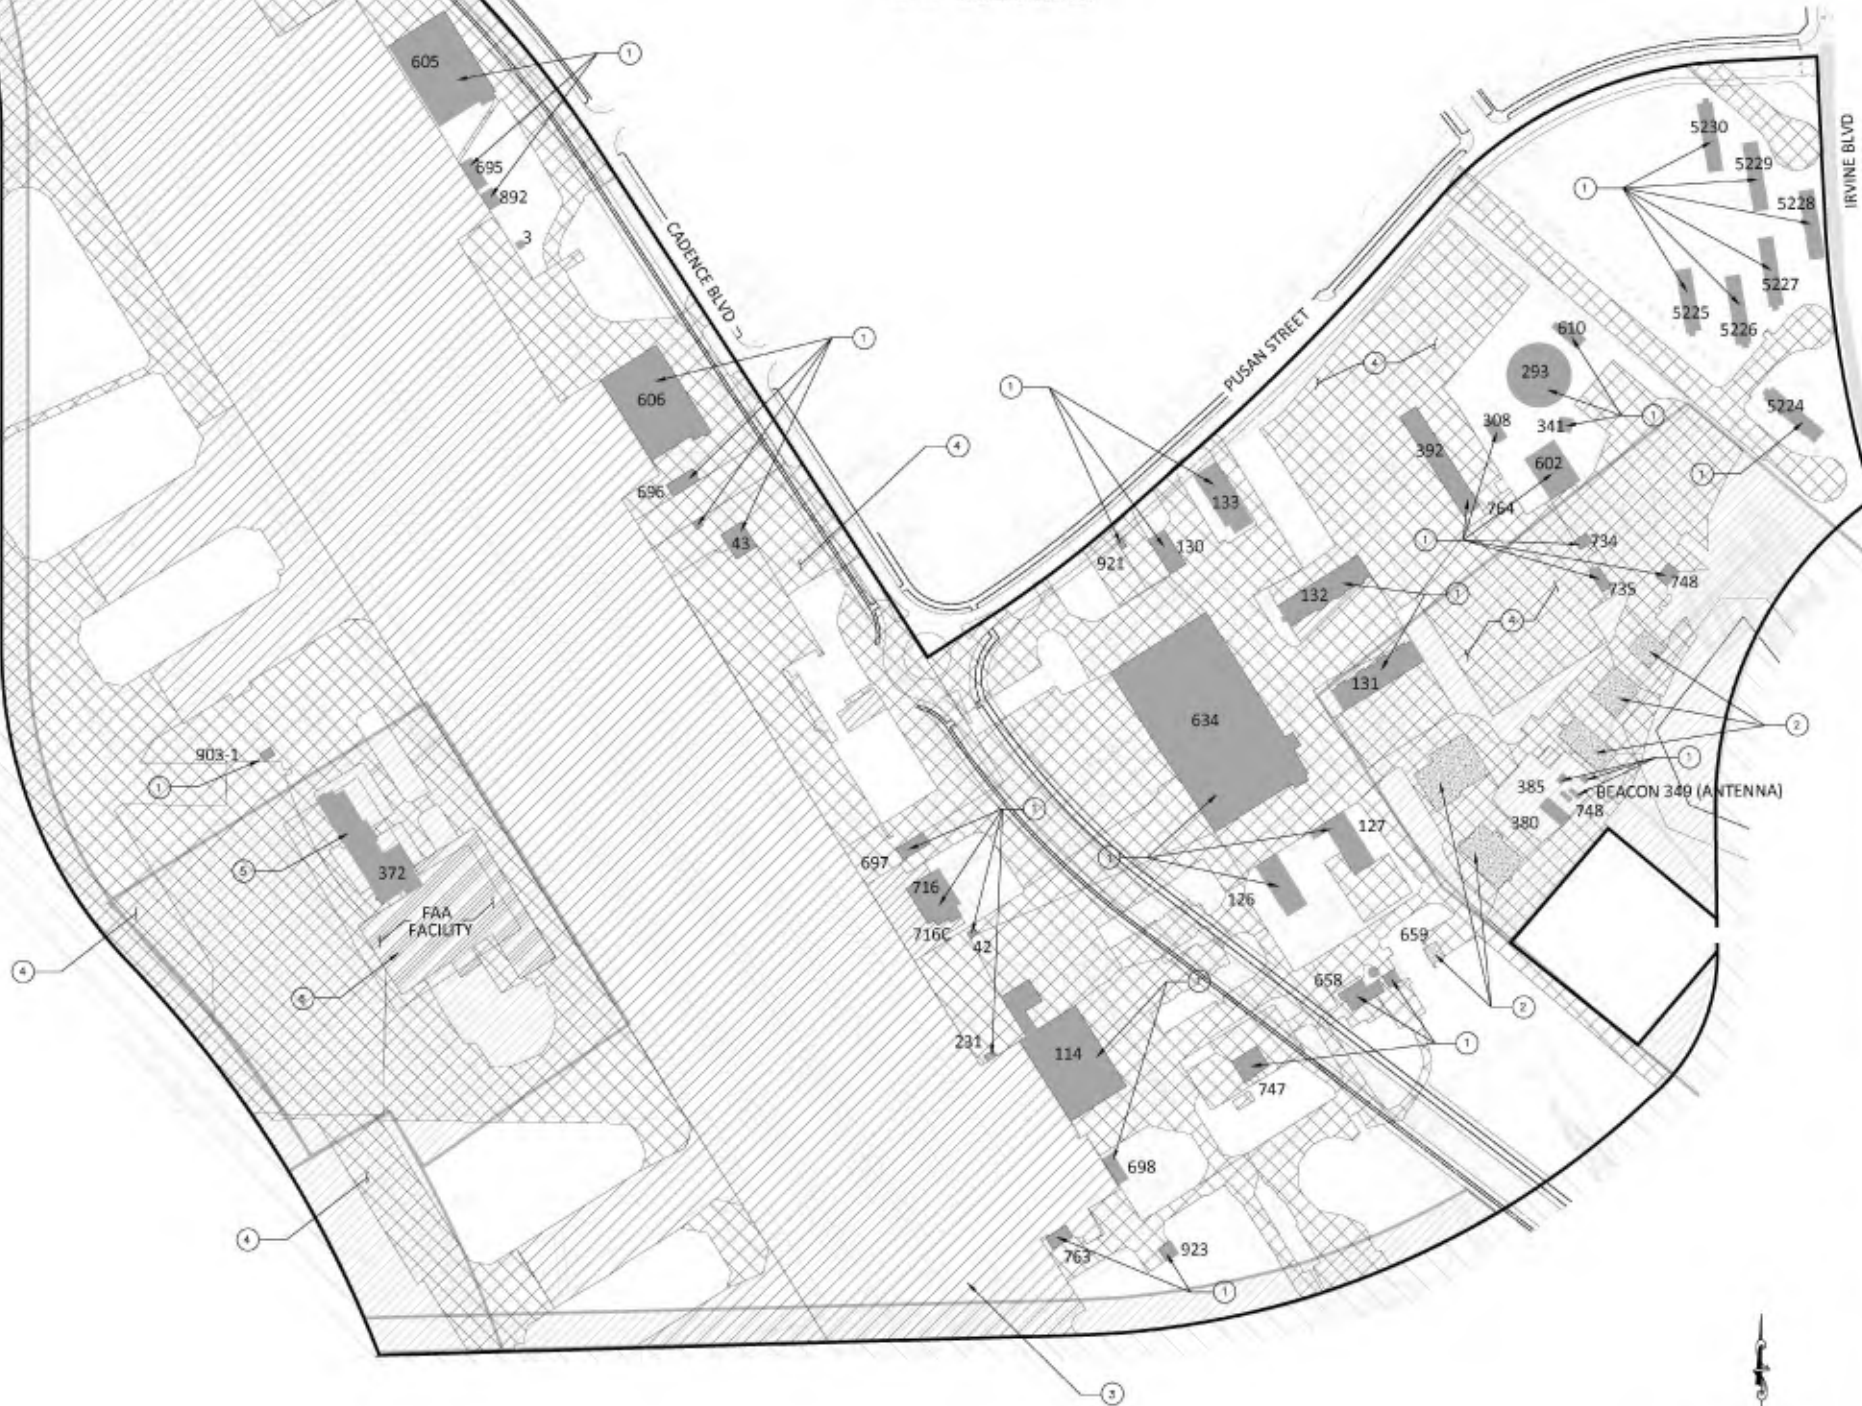
- EXISTING BUILDING, FOUNDATION, FLOORS, FLOOR SLABS, AND ANY OTHER UNDERGROUND BUILDING STRUCTURE TO BE REMOVED
- EXISTING FLOOR SLABS, AND ANY OTHER UNDERGROUND BUILDING STRUCTURE TO BE REMOVED
- AIRSIDE HEAVY CONCRETE TO BE REMOVED
- LANDSIDE CONCRETE/ASPHALT TO BE REMOVED
- FLIGHT CONTROL TOWER BUILDING FUTURE USE/DEMOLITION TO BE DETERMINED
- FAA FACILITY TO REMAIN

Phase 1 - Part 1- Site Preparation and Demolition (125 acres): Phase 1 of the Project will include the demolition of the entire 125 acre site. Demolition includes existing 77 buildings (1,037,139 SF), foundations, floors, floor slabs, concrete, and asphalt. The demolition also includes the removal of underground utilities. Erosion and sediment control measures will be maintained at all times during the demolition.

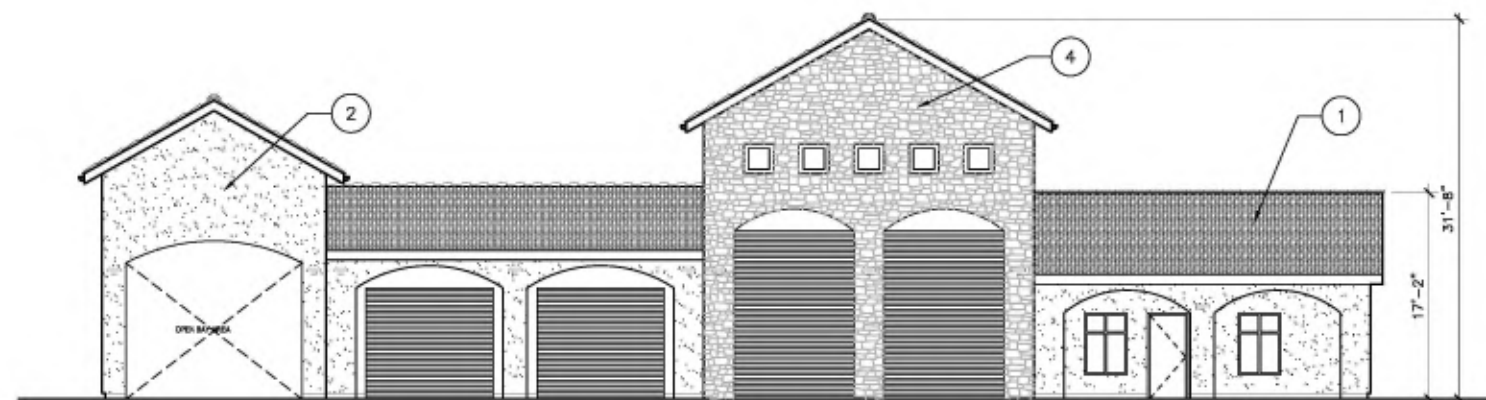
MAINTENANCE BLDG NORTH ELEVATION

- 1 SPANISH MISSION TILES BARREL TYPE
- 2 EXTERIOR CEMENT PLASTER
- 3 EXTERIOR PLASTER OVER CONCRETE MASONRY UNIT
- 4 STONE VENEER

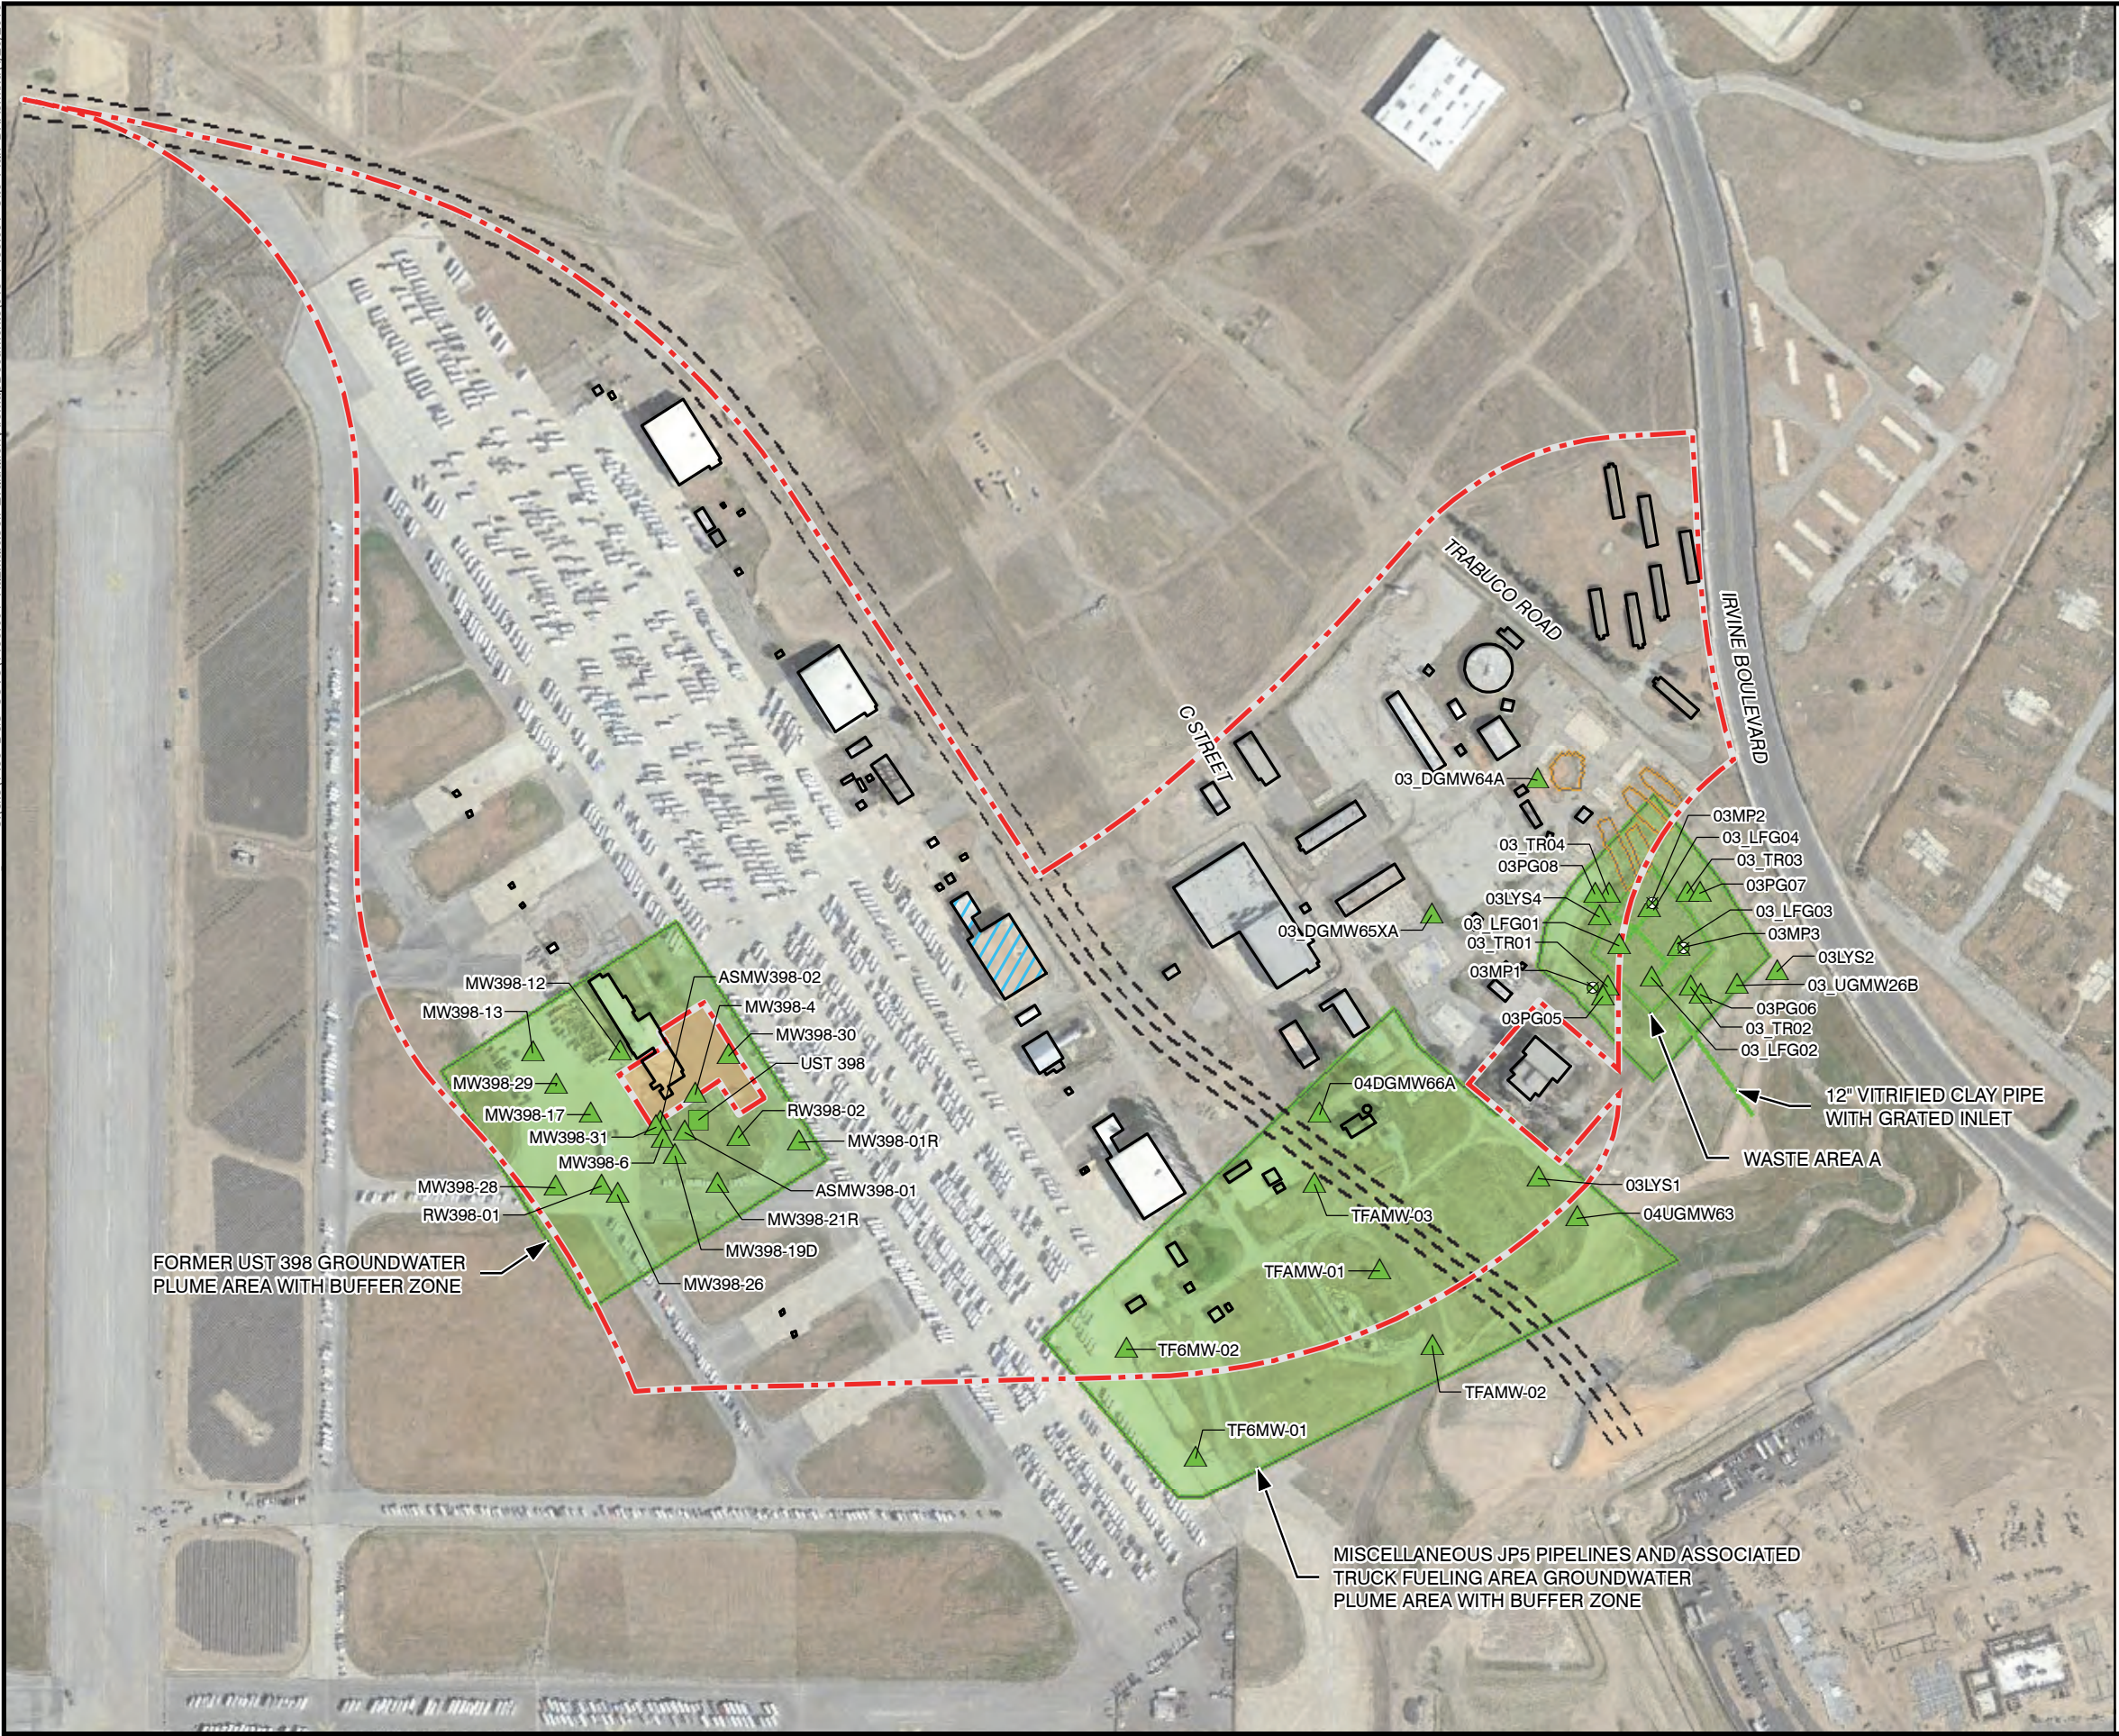
FIGURE 8
**SITE PLAN
WITH POTENTIAL ENVIRONMENTAL
CONCERNS (PECs)**
SOUTHERN CALIFORNIA VETERANS CEMETERY
DEPARTMENT OF GENERAL SERVICES
IRVINE, CALIFORNIA

The 59 PECs in or near the proposed SCVC boundary are summarized in Table 15 and their locations are shown in Figure 8. The PEC listings resulting from APHOs, MSC JP5 pipelines, OWS, PCBs, PRLs, and TAAs are based on possible residual impacts in shallow (less than 10 feet) soil beneath and around these features. More specifically, the two APHOs identified as PECs were based on reported surface releases of wash water and/or possibly petroleum hydrocarbons. The MSC JP5 pipelines were included as PECs based on past evidence of leakage in other areas of MCAS El Toro. The three OWSs are considered PECs based on their being abandoned in place or having been subject to multiple subsurface investigations. Two PCB locations identified as PECs were due to trace concentrations of PCBs detected in confirmation samples collected during prior inspections. The three PRLs listed as PECs are due to impacted soils or stained surfaces found during a prior inspection. Three TAAs were identified as PECs due to them having impacted the underlying soil based on prior sampling.

As part of the evaluation, Avocet identified 32 USTs as PECs, although 6 were either on or outside the project boundary. The UST PECs are based on either documented/suspected subsurface impacts or the USTs having been abandoned in place. The locations of abandoned-in-place USTs are shown in Figure 8. If the USTs are indeed still present, they will have to be removed as part of the development for the SCVC.
